# Building Resilience in the Reinland Channel

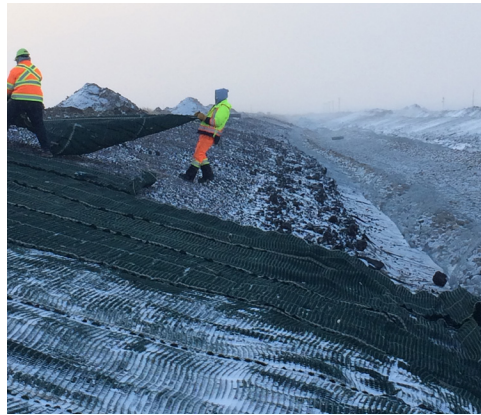
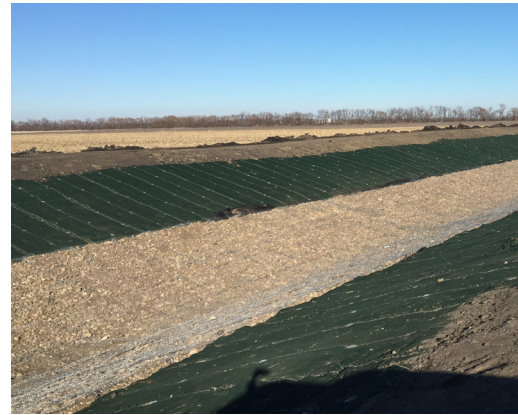
PROPEX Armormax was used to stabilize the side slopes of the channel. Due to delays in construction, project engineers had to overcome challenges such as an accelerated installation schedule and frozen soil.

Another challenge presented by the winter installation schedule was that the soil froze, creating a three-foot-thick section of frozen ground. To overcome this challenge, the engineer used a longer securing pin that was within the acceptable specification range in addition to 3-foot B1 earth anchors. Additionally, the contractor pre-drilled the anchor locations through the frozen soil to improve the anchor installation rate.

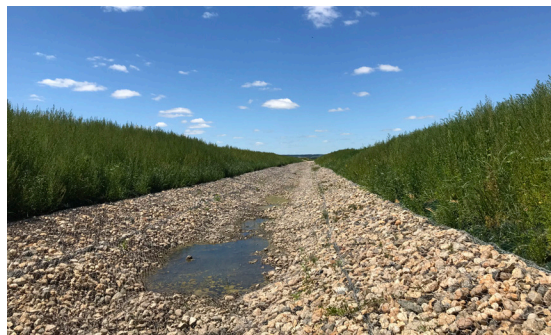
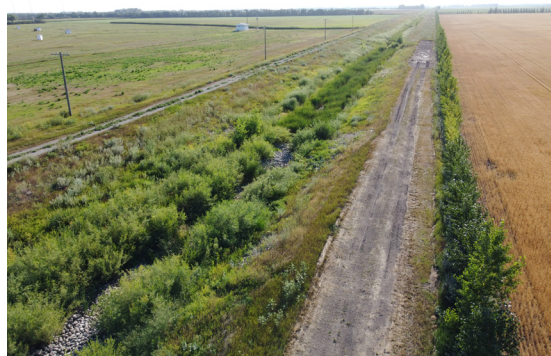
Vegetation establishment five months after installation (top) as well as channel performance five years after installation (bottom).

Within six months, the channel was vegetated. Currently, the project has been installed for five years and has experienced major weather and flood events without need for maintenance or repair. **II**
